Dry Berth of Battleship TEXAS State Historic Site

Phase I: Conceptual Design Report

September 29, 2011

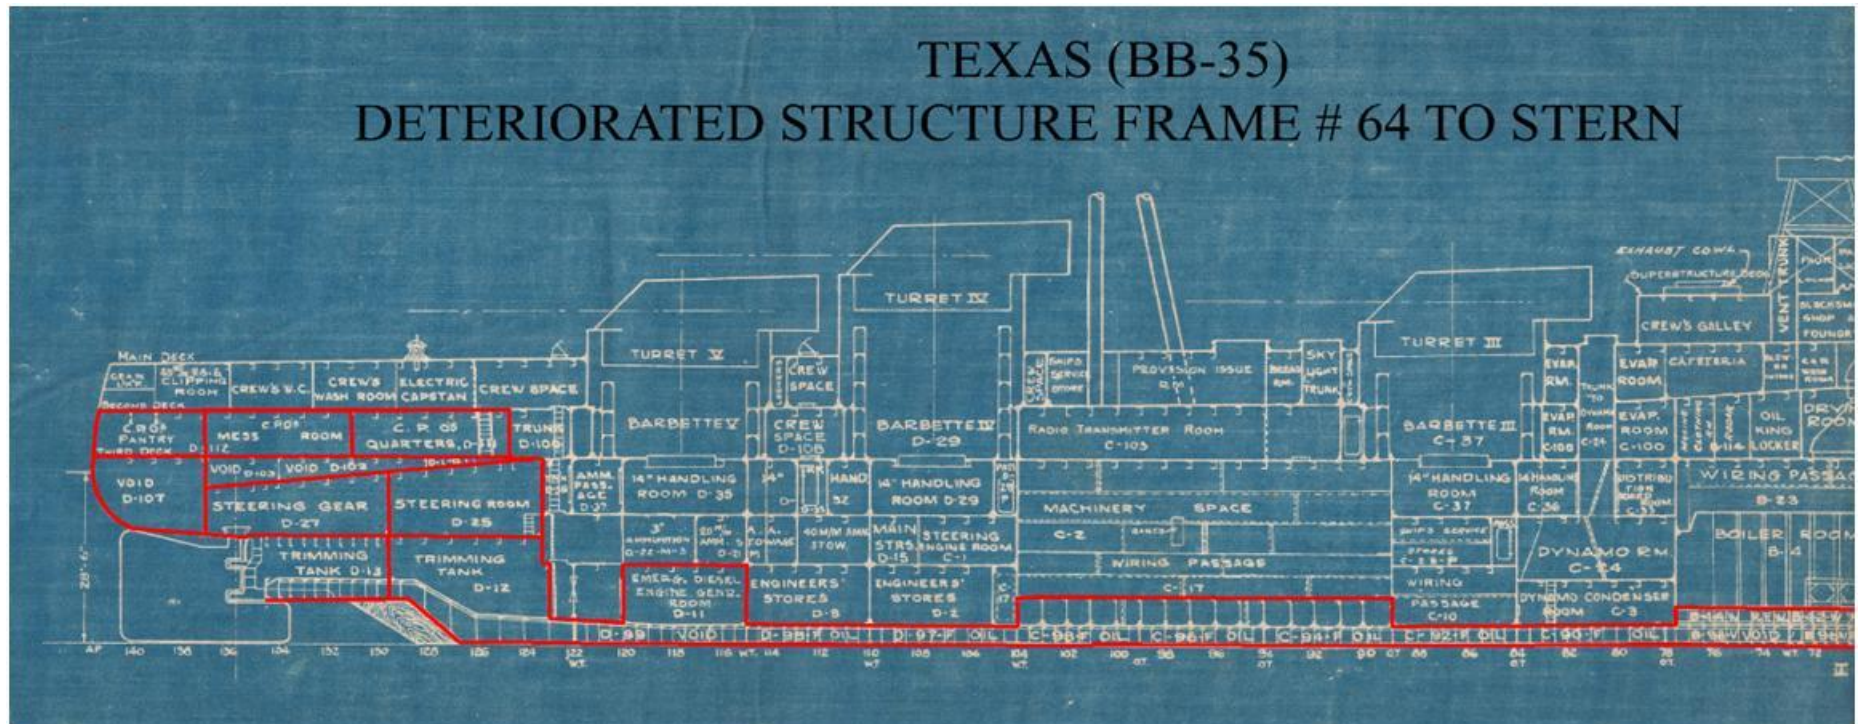
Figure 1-6: TEXAS BB-35 Critical Areas

The Vessel Inspection and Assessment Report by AECOM Subconsultant Ocean Technical Services (Attachment E) presents a comprehensive condition survey of the vessel as obtained from a detailed inspection carried out from November, 2010 – January, 2011. Critical problem areas have been identified as those that merit immediate consideration before the re-floating of the vessel and before the towing of the vessel to its temporary or final berthing configuration. Unless these issues are addressed satisfactorily before the vessel is re-floated or towed, there is significant risk in causing irreparable damage to the vessel. Attachment E documents the Ultrasonic Testing (UT) and corrosion analysis results from a diving survey, and the stability assessment of the vessel, respectively. The critical problem areas observed during the inspection, highlighted in Figure 1-6, are as follows:

1. **Outboard Blister Tanks** - The UT results showed severely wasted or holed plating throughout the length of the vessel on both Port and Starboard sides. Tugs cannot rest against the majority of the blister tank system on either side. The interior structural support members for the shell plating were either severely deteriorated or non-existent, and have separated from the armor belt above and shell plating below.

2. **Hold and Inner Bottom Tanks** - The lower 8 ft of inner bottom and hold are in an extremely deteriorated material condition and need to be rebuilt. Much of the interior scantlings have greater than 60 - 80% loss and are failing due to heavy weight loads (boilers, main engines, etc.). There is no transverse watertight integrity of the main bulkheads. The structural frames, bulkheads and foundations for the hold and inner bottom tanks aft of Frame No. 65 to the Stern are badly degraded. Aft of Frame No. 64 to Frame No. 135, all interior tanks contiguous to the centerline keel showed heavy to severe wastage.

3. **Boiler Rooms B-3 and B-4** - The foundations for the boilers within the boiler rooms are starting to fail with signs of badly scaled or compressed plating and foundations. The floor for these boilers is completely wasted through in many areas allowing views within the underlying hold tankage with approximately additional 40 – 70 % wastage in places. The underlying support frames and longitudinals within the tankage in the hold and inner bottom are severely bent, totally wasted away or non-existent and showing ready signs of eventual collapse. The side shell on both sides appears fine with no leakage from outboard tankage, piping or manifolds.

4. **Aft Trim Tanks D-12 and D-13** - This space has deteriorated throughout to a dangerous degree. The tank shell plating, longitudinal frames and keel exhibit greater than 80% loss with heavy leakage noted on the forward starboard side at the wind/waterline and to port opposite. There are badly tripped and distorted transverse frames throughout the space. The shell plating below the waterline are continuously leaking, requiring a float-type bilge pump to be engaged at all time.

5. **Engine Rooms** - The main engine foundations (particularly the port side unit) have failed and are a serious structural and safety concern. The six tanks under the pair of main engines are freely flooding. Of concern is the foundation in that the weight of this structure depends upon the strength of the three underlying inner bottom tank scantlings. There is very little material left within the scantlings below (engine room floor, transverse frames, longitudinal frames, keel) the main engine and a lack of support from the inner bottom tanks.

6. **Chief Petty Officer (CPO) Spaces** - There is severe deterioration Aft of Frame No. 120 up to the Third Deck. The tankage, trim tanks and upper deck main supports (vertical main stanchions, from shell plating/keel up to the bottom of the Second Deck), which includes the CPO spaces on Half Deck after Frame No. 115 have failed, or are soon to fail. The bulkheads, transverse web frames, floors and keel are in poor material condition and in jeopardy of failure. The vertical support

stanchions in the CPO Quarters supporting the Second Deck are severely corroded with wasted pedestal bases. The deck itself is severely wasted and unsafe in many areas. The side shell tanks are entirely wasted away. The transverse bulkheads are non-watertight and are holed. Tugs cannot rest against the stern plating on either the Port or Starboard sides, nor can they exert any pull on the stern/main-deck cleats, bollards and chocks.

7. **Steering Gear, Steering Room and Overhead Void Spaces** - The deck is wasted and holed with wastage greater than 60-70% over a wide area. Transverse web frames have failed entirely. The overhead sheathing, support framing, bulkheads and vertical stanchions supporting the turtleback on the overhead sheathing have failed, or are soon to fail, due to corrosion. The deck itself is poorly supported by the transverse frames and stanchions. This entire area needs to be rebuilt to withstand the movement of the ship and to impart any strength while on the keel blocks to support everything under the Third Deck.

Based on an assessment of the stability (see Attachment E) as well as general structural condition of the ship, the following recommendations are provided with regard to any dredging (of the current slip) or towing of the ship:

- The need for monitoring of the ship will be required during any dredging at the slip or towing of the ship, due to the very poor material condition of the ship.

- In a floating condition, there is a significant danger of loss of stability for the vessel due to the possibility of up-flooding into large off-center spaces.

- Existing and supplemental pumping capability will be required onboard to keep the vessel stabilized whilst in a 'floating' condition even after temporary repairs have been completed.

- Tugs cannot be allowed to push on side plating in order to maneuver the ship
- The use of monopiles remains necessary should the vessel be moored to a temporary location as the vessel's blister tankage is not capable of supporting the side loads of the ship against fendering.

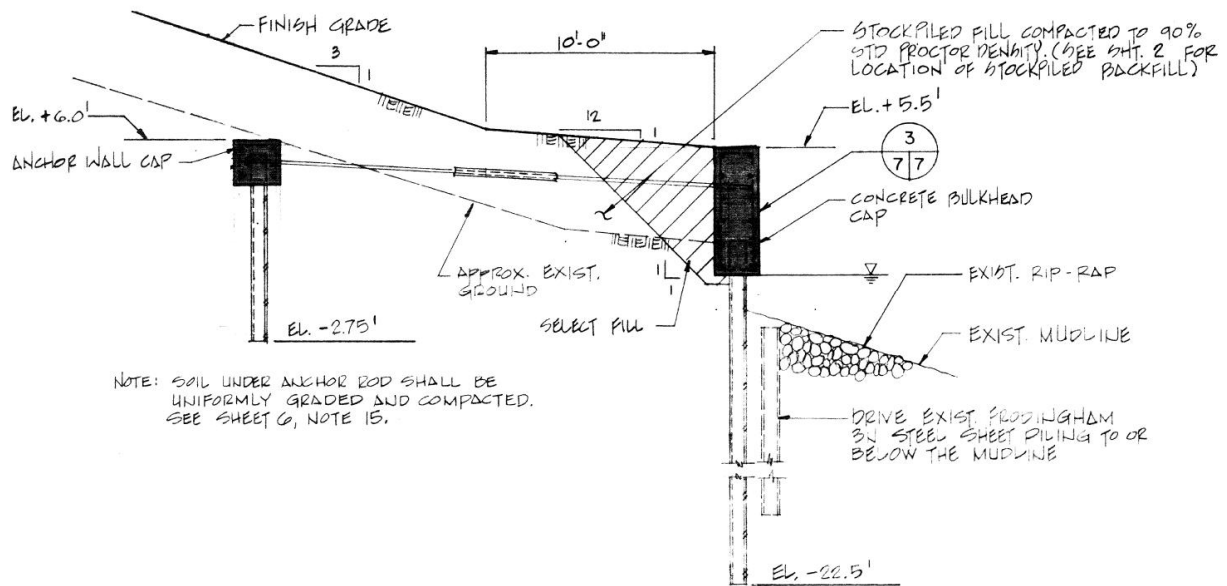
Figure 2-2: Existing Sheet Pile

The existing south sheet pile was saved by maintaining the required slope for safe stability considerations for both dry berth Options 1 & 2. See Figure 2-2.

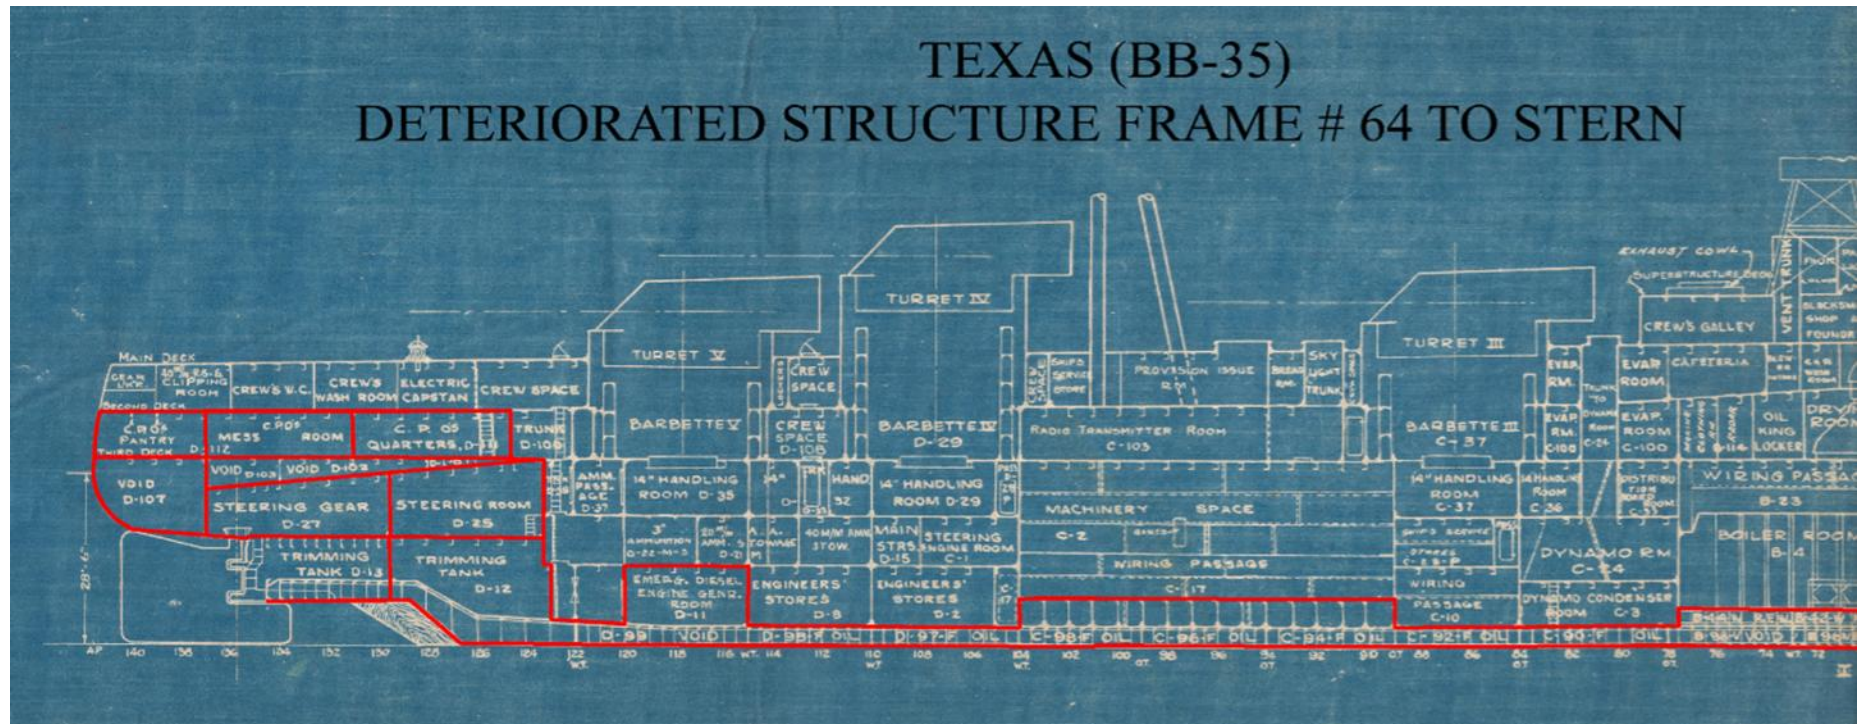
Figure 6-1: TEXAS BB-35 Critical Areas

should remedy the ongoing problem. Repair recommendations are provided within the main body of the report.

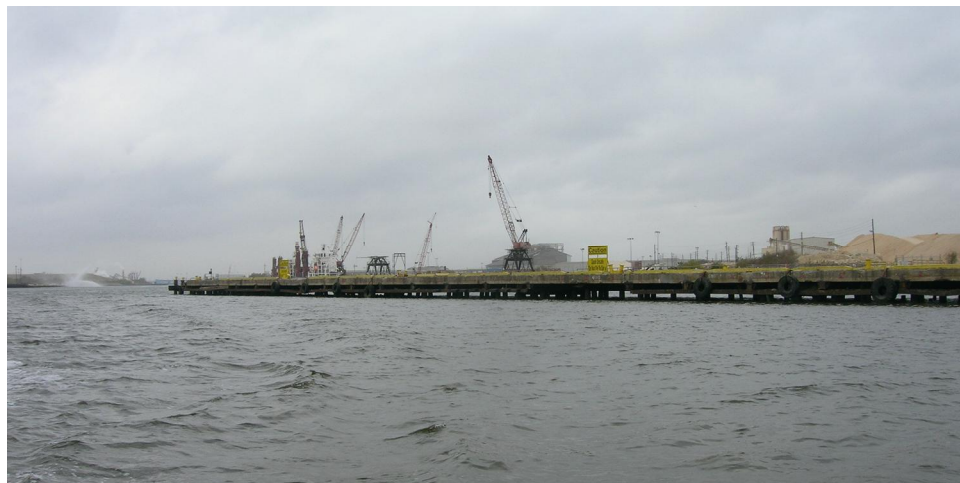
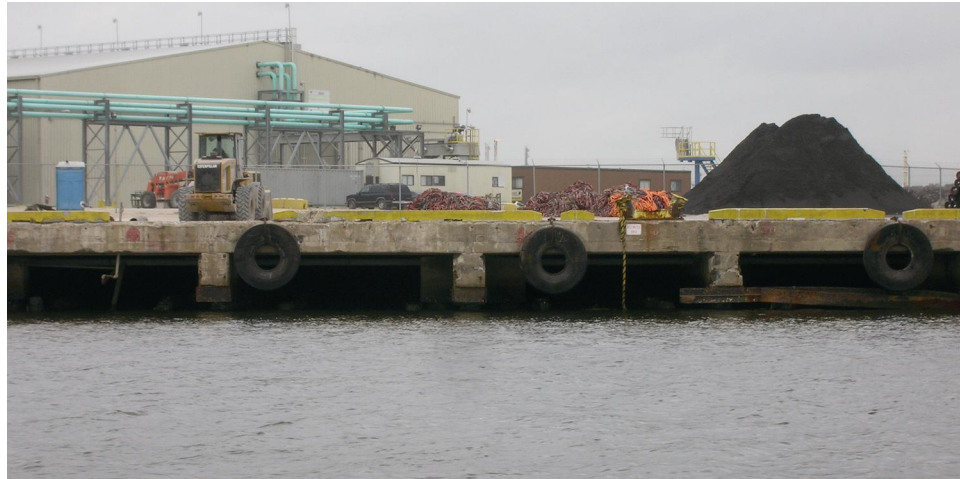
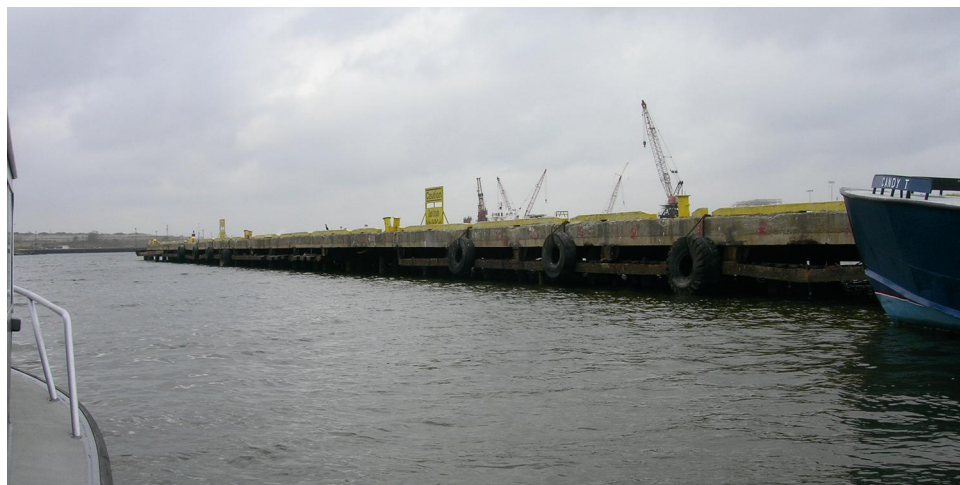
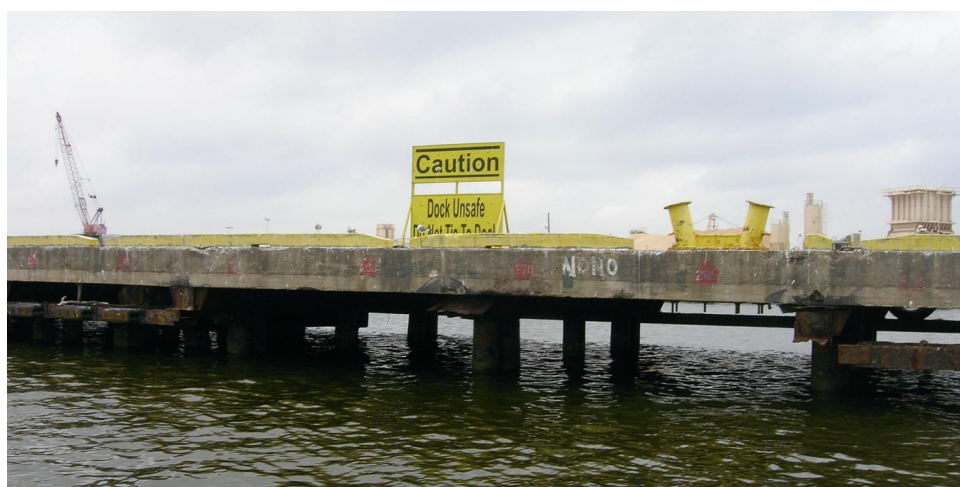
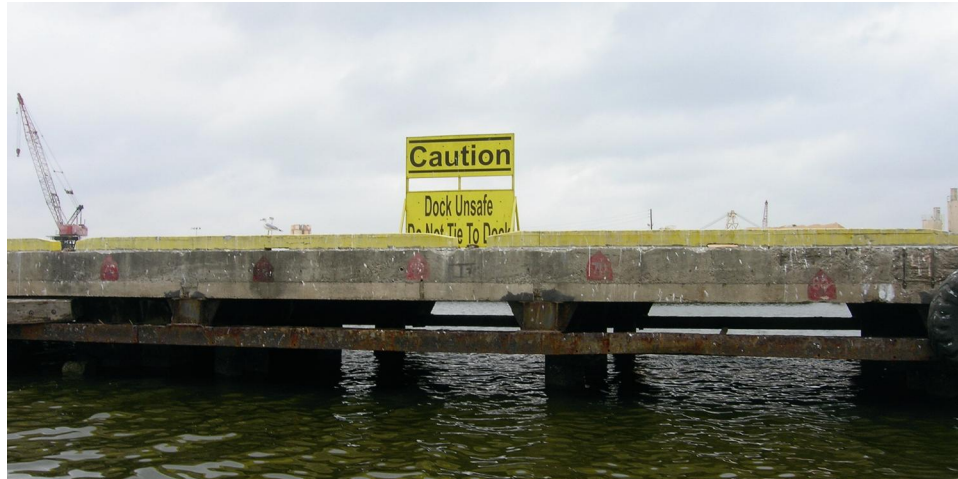
Greens Bayou terminal is not adequate structurally to support the vessel forces for mooring and berthing the TEXAS. Therefore, the costs were not estimated and it is recommended that the location is not subject to further investigation as a temporary berth for the vessel. See the photos below.
